H-24/60
SOLID PANEL
WITH VIEWPORT CUTOUT

MAXCESS ALUMINUM FLOORS, INC.

No. CS-3014

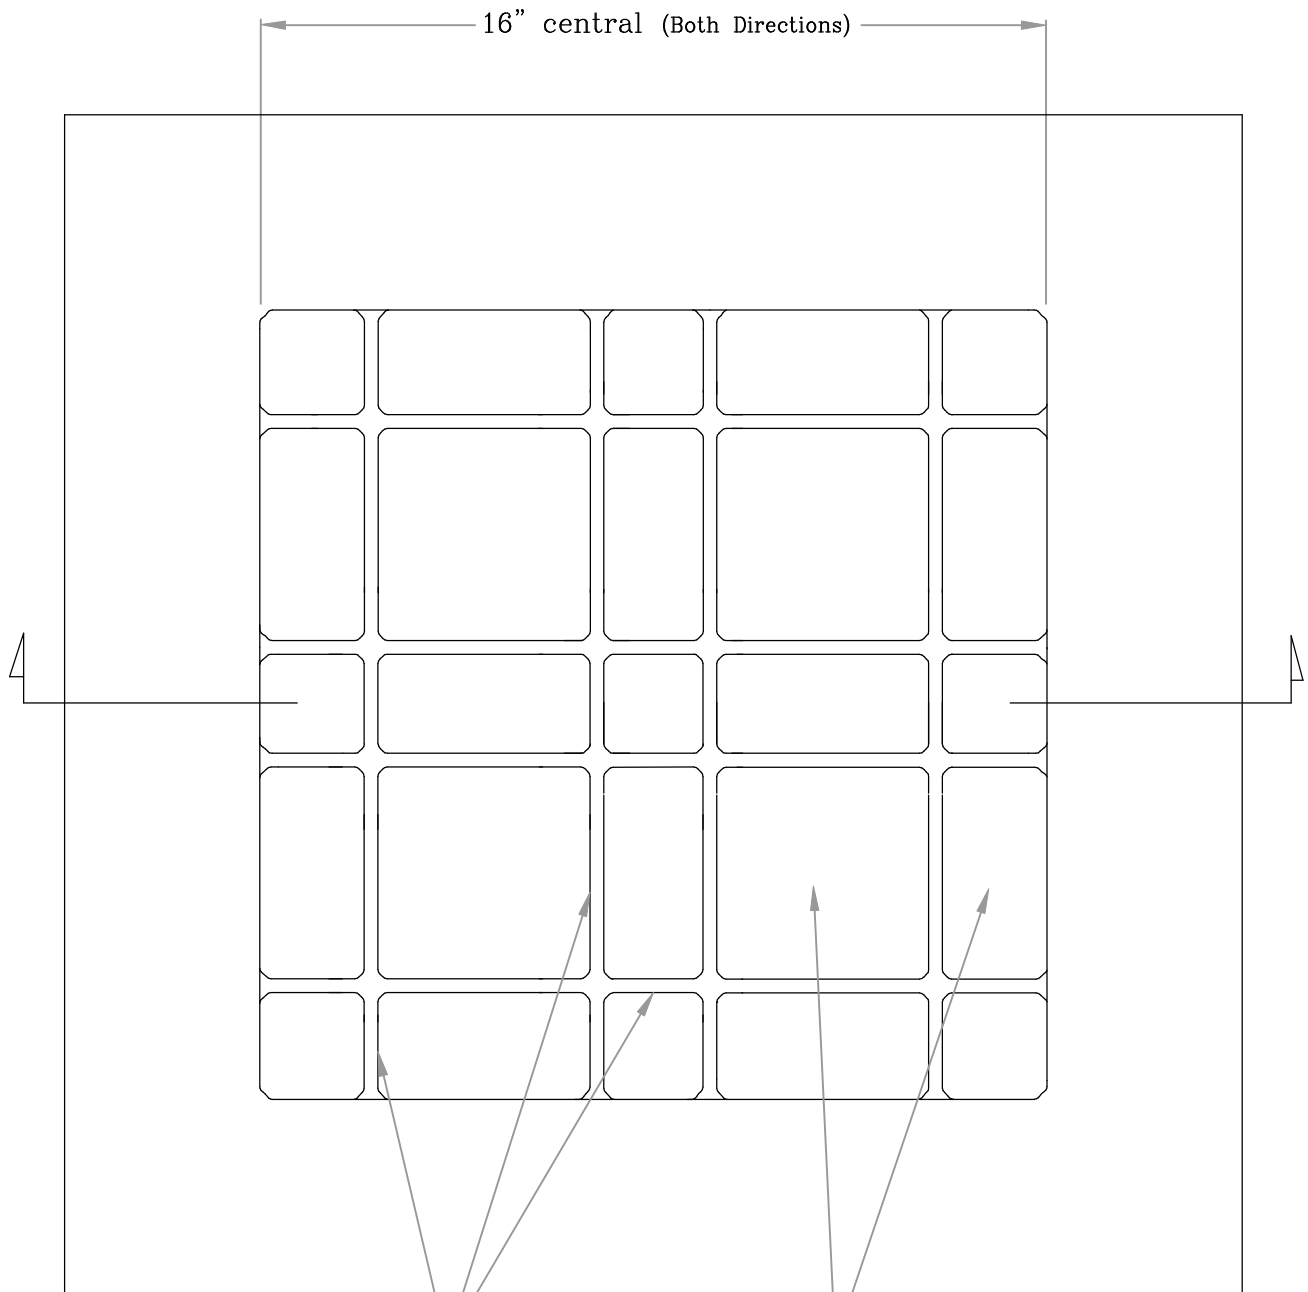
Primary ribs (as shown)
Machined to .50"
below top surface

Secondary ribs removed
For areas as shown

Material:
Die Cast Aluminum
